<i>Prepared by</i> Paul Rickerli	<i>Date</i> 27.08.2003	<i>Classification</i> Unclassified	<i>Work order (AO)</i> 579 023	<i>Page</i> 1 (16)
			<i>Designation</i> VoVC 14 764:46591/03

## Verification of Mine Clearance Vehicle 1 /T deep mine clearance machine.

Effect on the driver in the detonation of a 10 kg mine.

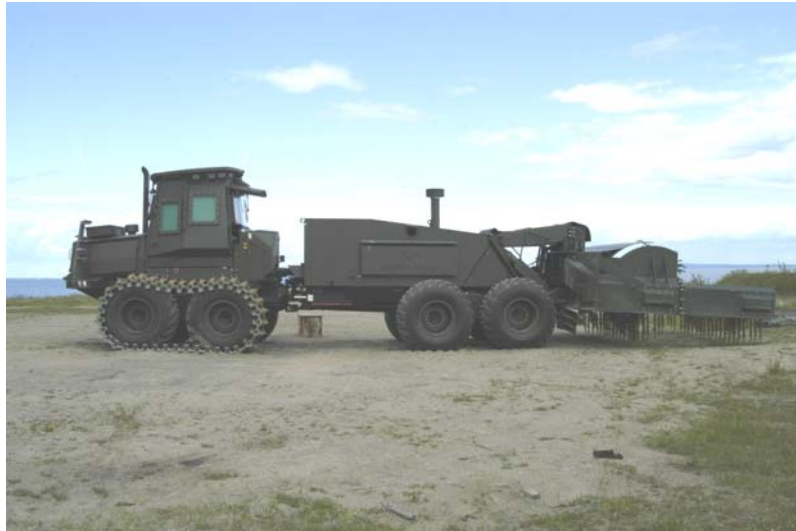
**Figure 1: Mine Clearance Vehicle 1 /T deep mine clearance machine**

The ground clearance under the cab part was 670 mm and the distance between the insides of the wheels was 1740 mm. In addition, the distance between the driver's cab and the clearance unit is approximately 10 m. The integrated frame and V-shaped belly plate of 8 mm steel in the cab part is a strong structure and largely prevents the pressure from the mine reaching the cab floor.

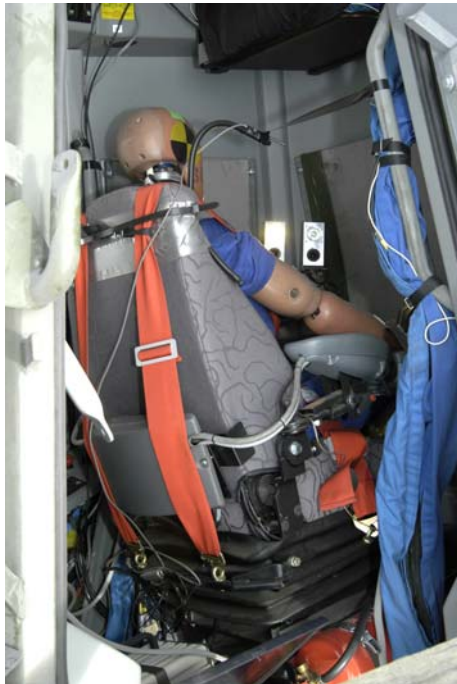
**Figure 2: Crash dummy Hybrid III in driver's seat.**

The driver's seat was of a standard model with air suspension but without a head restraint and wings. The anthropomorphic crash dummy Hybrid III weighing 78 kg was positioned in the seat (Figure 2). The dummy was clamped in place with the four-point belt. For the dummy to be able to have its feet on the footrest and the upper legs resting on the seat, the level of the seat was adjusted so that it was only a few centimetres from its lowest position.

The dummy's feet rested entirely on the footrest. Both feet had shoes on them. The body was held in a four-point belt with the shoulder straps joined at shoulder height behind the backrest of the seat (Figure 2).

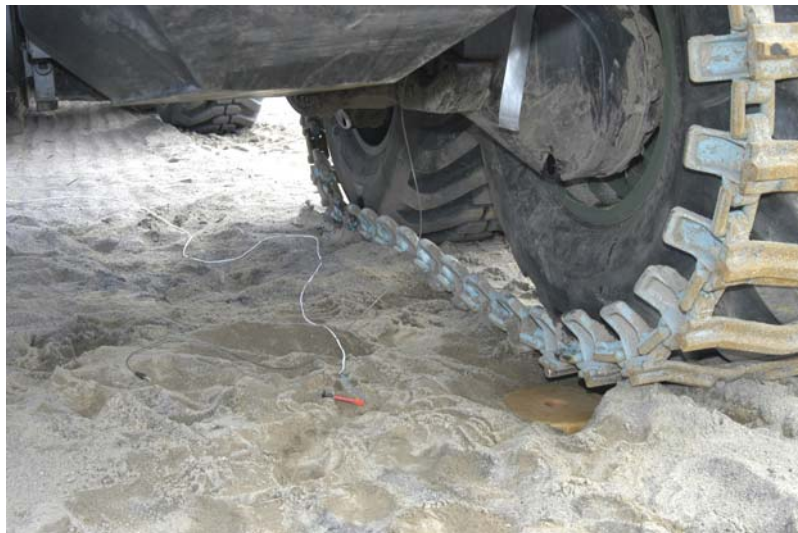
**Figure 3: Location of the mine under the right rear wheel.**

The charge was placed lying in a pit dug under the right rear wheel, half under the track and have in towards the mid-line of the vehicle (Figure 3). Sand was filled on top of the mine so that the top of the mine was 10 cm above ground level.

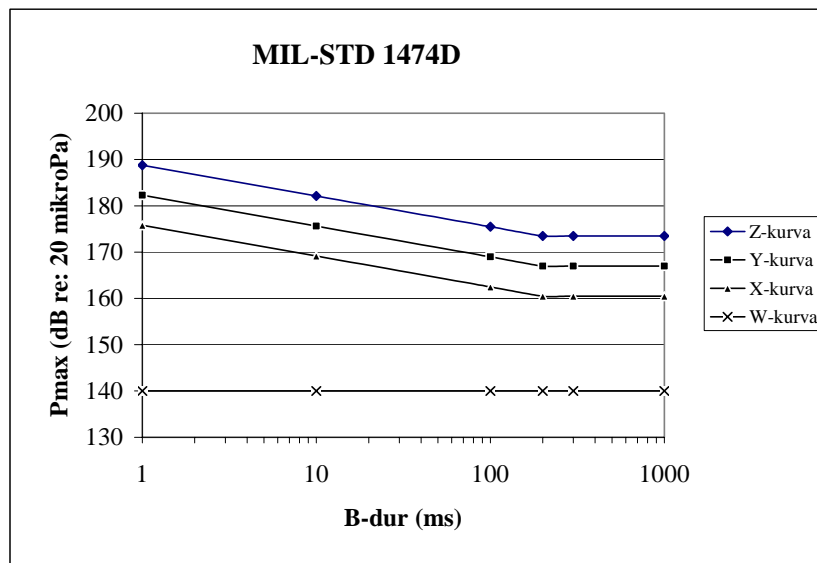
**Figure 5: Limits for maximum positive pressure (Pmax) and durations (B-dur) applicable to the tolerance of pressure waves from firing and blasts of the human ear. The degree of protection of hearing and the maximum number of exposures are shown in Table 2.**

If Pmax exceeds 140 dB (the W curve in Figure 5), ear protectors (plugs and/or muffs) must be worn to avoid damage to hearing. For Pmax lower than 140 dB (the W curve), a serviceman may be subjected to an unlimited number of exposures and without ear protectors.

The Z-curve constitutes the upper limit of what a human may be exposed to without incurring hearing damage. The X and Y curves are between the W and Z curves. Methods are indicated in MILSTD-1474D for calculating the number of exposures between the curves W – Z.

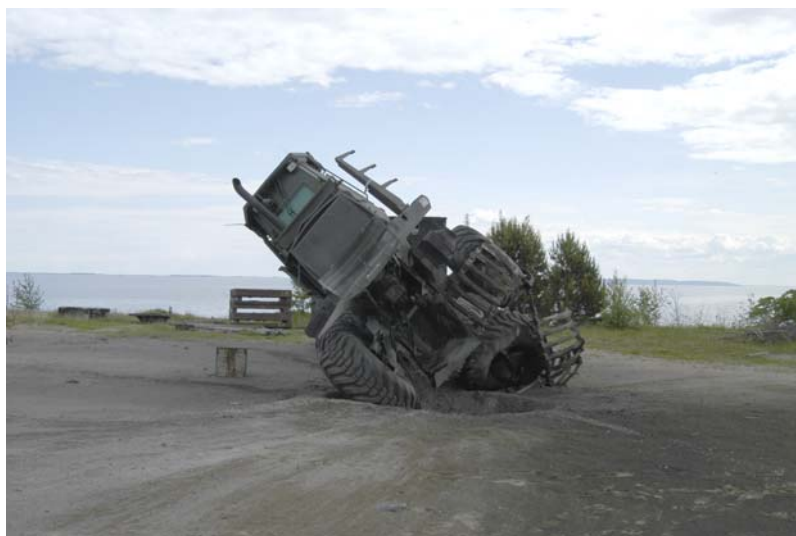
**Figure 6: The vehicle viewed from the rear.**

The violent throwing-up of sand and detonation gases largely made it impossible to follow the movement of the vehicle, and only its final position could be established. The cab part had twisted to the left around the articulated steering and was at a slope of around 45 degrees (Figure 6), which meant that the mine-clearance part had been raised at the rear and the front edge of the unit rested on the ground. It could be seen from tracks in the sand that the four wheels of the mine-clearance part had not moved but remained in their original position.

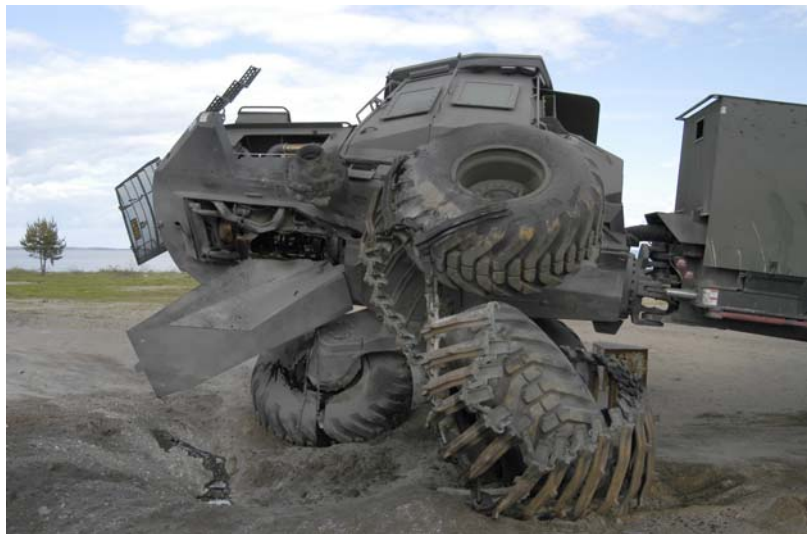
**Figure 7: The vehicle viewed from the left with loose engine belly plate.**

Some of the damage was that the right rear wheel, under which the charge was positioned, had loosened but was entangled in the track under the front right wheel of the cab part (Figure 7). In addition, the belly plate under the engine had been pressed in and had damaged the oil sump, after which it had dropped down. The pressed-in belly plate made it possible for the pressure to some extent to act on the floor of the cab.

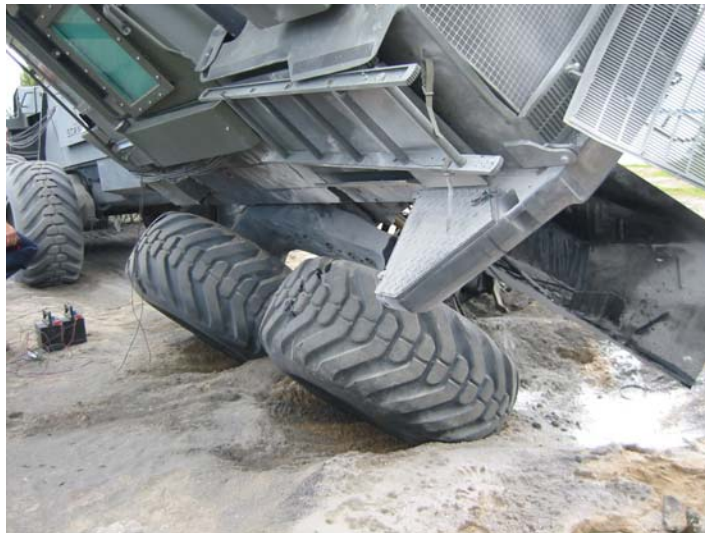
**Figure 8: The vehicle viewed from the left.**

As well as the right part of the cab moving upwards, it rotates 45 degrees to the left around the articulated steering. The left wheels dig down into the sand a few decimetres (Figure 8).
